Characteristics of Liquefaction-Induced Damage in the 2011 Great East Japan Earthquake

K. Ishihara

ABSTRACT: Features of the 2011 earthquake in Japan are characterized by predominance of the ground failure due to liquefaction and scour of the ground caused by Tsunami. Unprecedented long duration of the shaking and extensive occurrence of liquefaction in Tokyo Bay area 300~400km distant from the epicentral area are also the characteristic features of the earthquake. Many specially designed tsunami seawalls were destroyed by the raid of the giant tsunami as high as 15~20m in the coastal region of the northern part of Japan mainland. The results of preliminary investigations and simple analysis on the liquefaction-induced damage are introduced herein, together with lessons learned from the destruction.

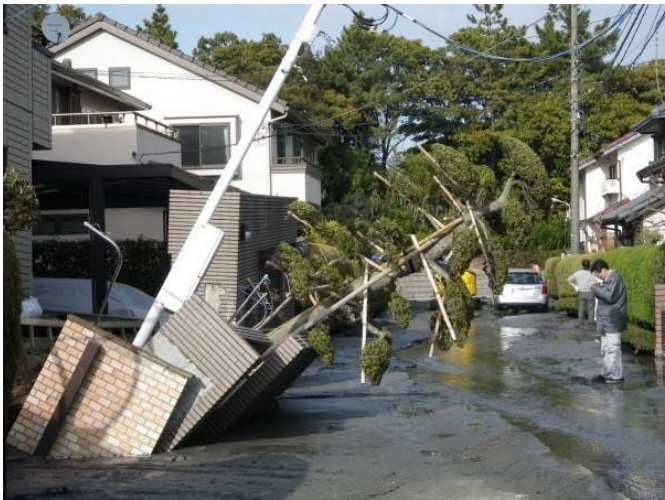
Several of photos showing the ground devastation by liquefaction are shown in Figure 21. Figure 21(a) shows tilting of trees and electric cable-supporting blocks at a house in Mihama residential section. Shown in Figure 21(b) is uplifting of a sewage manhole about 1.5m above the ground. The features of the ground damage in general are shown in Figure 21(c). It should be noted that the ejected sand was mostly laden with silt and clay, making it easy to flow and spread over the ground surface. Figure 22(a) shows a photo indicating settlement and tilt of a house. Figure 20(b) shows a house tilted and settled as a result of liquefaction. In the building supported by firm foundations such as piles, considerable vertical offset developed as typically displayed in Figure 22(c). The gap about 50cm between the building foundation and the subsided ground in its vicinity did result in breakage or tear-off of several pipelines and cables entering the buildings such as water and gas supply, sewage pipe, and electricity and telecommunication cables. The breakage of the lifelines as above was fatal for continued maintenance of operational conditions for the buildings. A conceptual picture illustrating the malfunctioning of sewage pipeline is given in Figure 23

(a) Ground devastation in a residential section

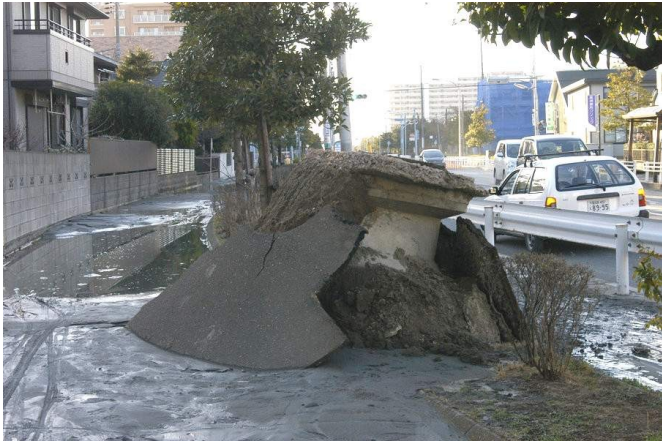
(b) Floating of sewage manhole

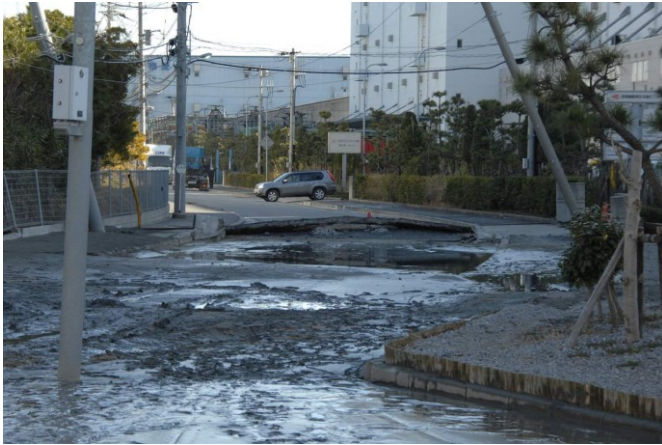
(c) Spreading of sand over the road

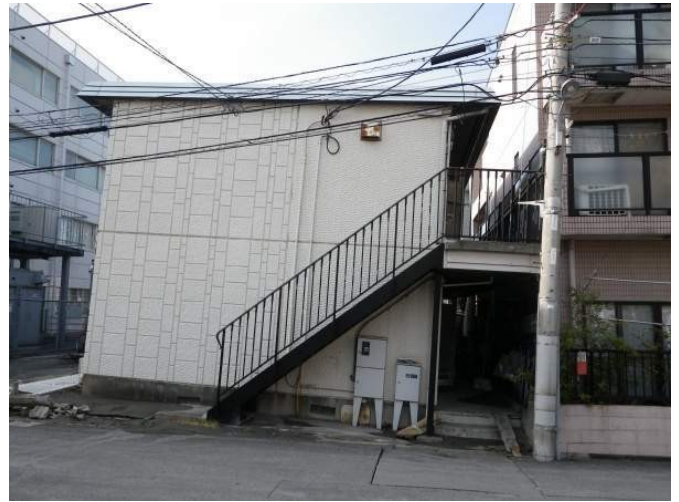
(b) Sinking of an apartment house

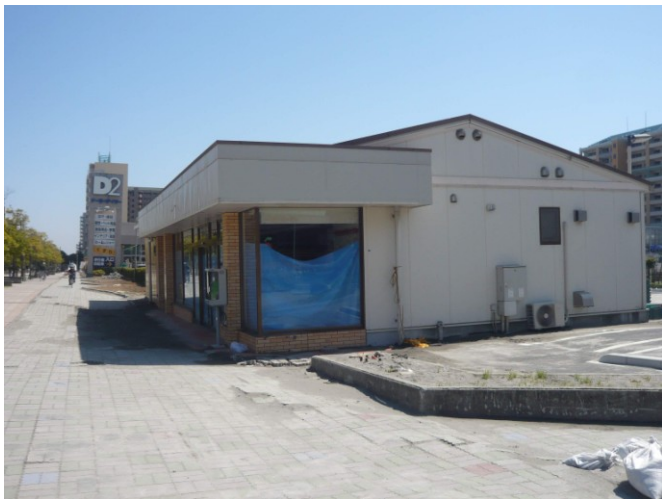
(a) Settlement and tilt of a building.

Figure 22 Settlements and tilt of houses due to liquefaction
(Offered by Urayasu city office)

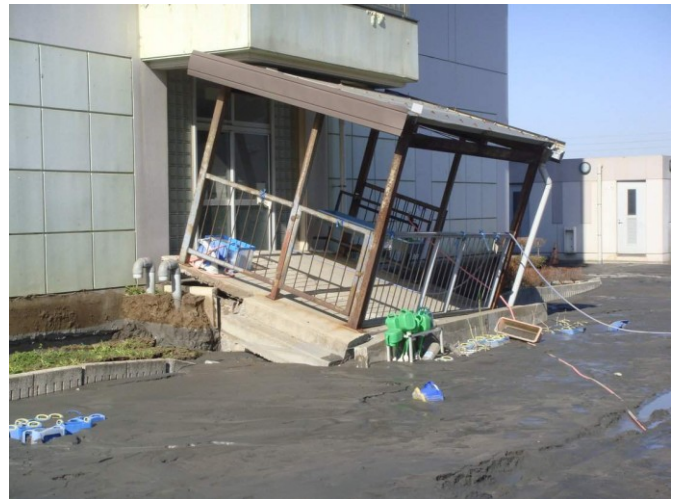
(c) Offset between an undamaged building and settlement of the surrounding ground

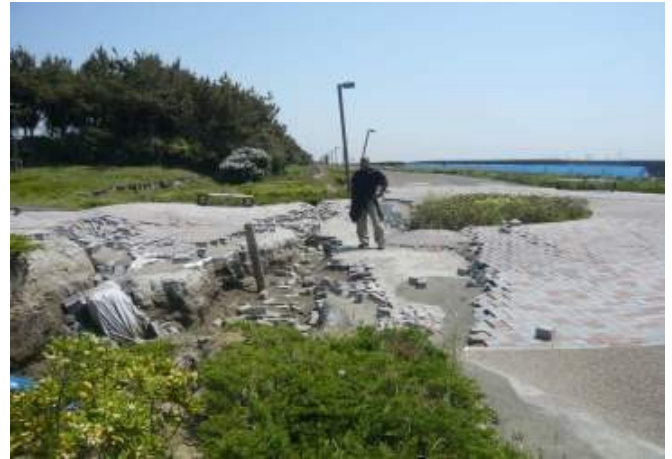
It appears likely that the man-made fills underneath the apron as well as those in the landside of the concrete seawall were all placed while lightly compacting sandy soils by means of bulldozers which remained still loose enough to trigger liquefaction. Coming back to the landslide in the cemetery park shown in Figure 25, one can envisage that the overall liquefaction through the distance of 110m in the cross section is accompanied by the lateral flow of the liquefied silt-laden sand.

(a) A depression of the ground inland of the seawall - a view to the East

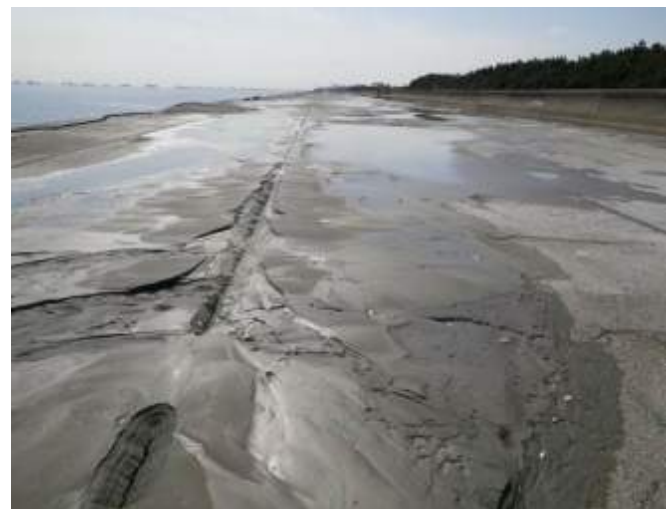
In fact, the seaward edge of the asphalt-paved apron was seen having moved laterally through 1.0 to 1.5m, thereby breaking off its edge and falling down into the wave-breaking concrete blocks. As viewed in a photo in Figure 24(b), traces of sand ejection were observed through open seams of pavements in the apron.

(b) Sand gushing from a seam of pavement in the apron in front of the seawall – a view to the west

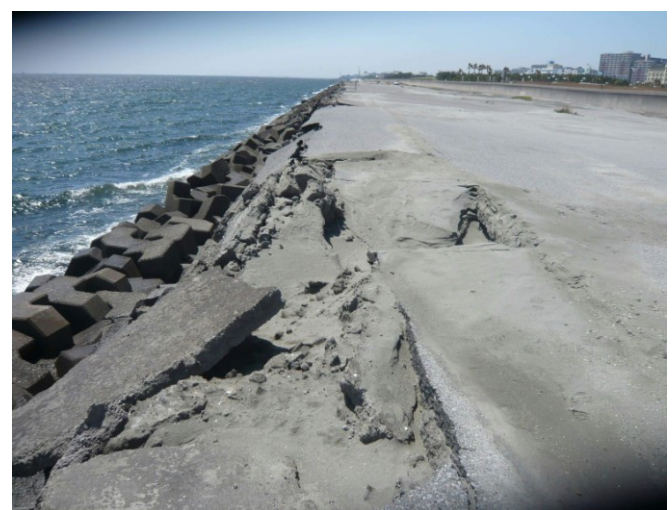
(c) Damage at the edge of the apron - a view to the west

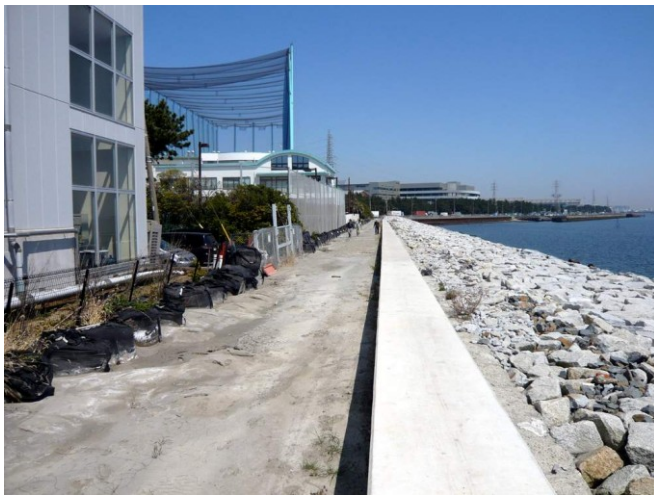
(a) A view of the undamaged seawall (centre) with extensive liquefaction at inland walkway - a view to the east

Although there was strong shaking of the order of 150~200gal plus the following rise of about 1.0m in the sea level due to Tsunami, the seashore protection structures as above remain almost intact and fulfilled its intended purpose.

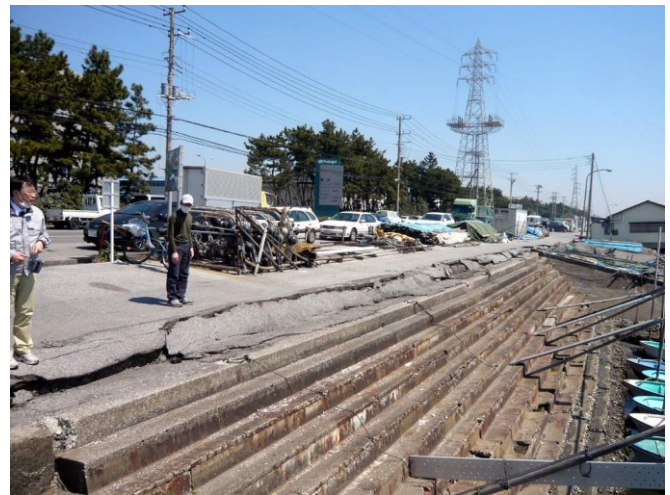
(b) Damaged steps in the fishery port with the lateral displacement of about 50cm - a view to the east.

Shown in the photo of Figure 26(b) is the damage to fishery port in Ichikawa involving lateral displacement of the order of 30~50cm at the crest level. Considerable evidences of liquefaction were observed along the belt zone along the seashore road as shown in the map of Figure 27.

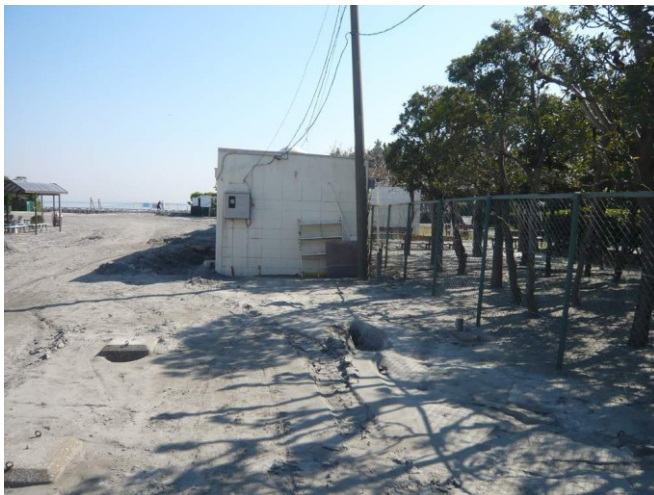
which were difficult to make access for site investigation, but these appear to be protected by the pile or H-beam supported concrete seawalls. Most pronounced damage was to houses and facilities in Funabashi Seashore Park located behind the sand dune of the beach line as shown in Figure 27. Overall ground subsidence of the order of 50cm occurred due to extensive liquefaction. Outdoor small shopping houses supposedly supported by flat foundations sunk by 50cm due to inundation of sand as shown in the photo of Figure 28(a).

(a) Sinking of a small house with overall spreading of liquefied sand - a view to the sea

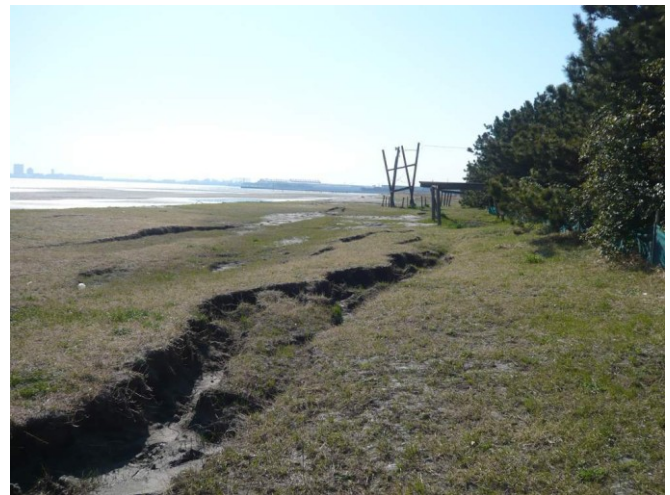
Along the beach line at the Park, cracks or fissures of the ground were observed, as displayed in Figure 28(b), resulting from lateral flow of the liquefied sand.

(b) Lateral spreading of the beach in front of the Seashore Park - a view to the west

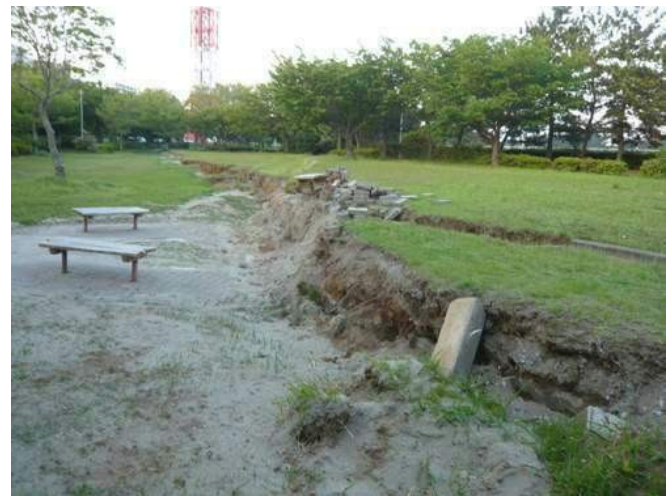
wide and 200m long, as indicated on the map of Figure 27, suffered a subsidence of about 50~100cm due to liquefaction. The photo in Figure 28(a) shows a vertical offset of about 50cm that had developed in the park through a distance of about 200m. The photo (b) showed the vertical offset in front of the 10 storey building on the north side of the road. It may be seen that the vertical gap of the order of 50~70cm in front of the building produced damage to facilities such as portal steps and fences. In the Traffic Park, east of the above mentioned area, traces of considerable liquefaction was observed on the ground surface, including development of widely open cracks and sand boiling. The photo in Figure 31(a), viewed from west shows open cracks, as wide as 0.7~1.0m, running through the park in parallel to the line of the Hanami River. Shown in Figure 31(b) is the end of the cracks, viewed from north, blocked by a one-storey office building. It is of interest to note the large push-in of the ground having developed along the periphery of the building due probably to punching interaction between the concrete foundation and the surrounding soil deposits that had liquefied. The depth of the push-in was 50~70cm relative to the flat level of the surrounding ground.

(a) Vertical offset in the park on the south side of the road

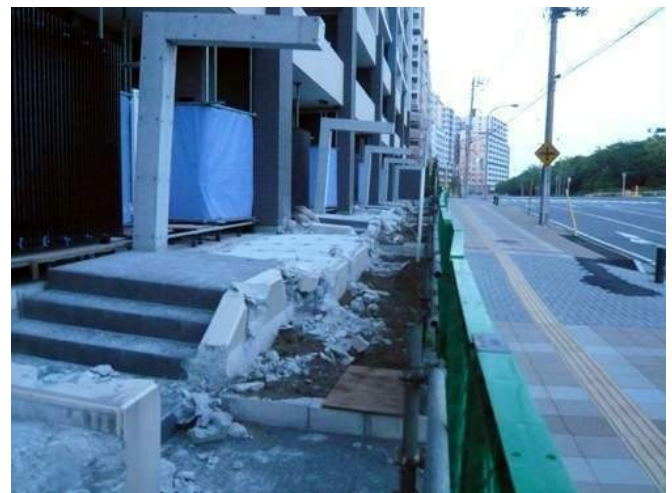
(b) Small facilities at the portal of the building

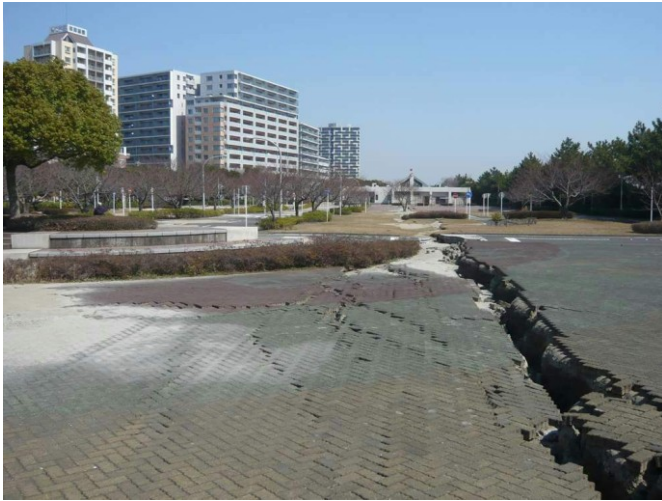
(a) Open cracks through the Traffic Park - a view to the east

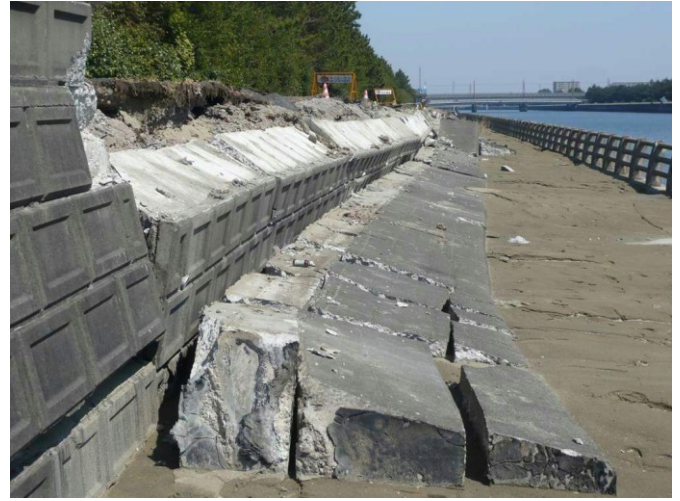
(a) Collapse of the wall north of the Hanami River – a view from the west

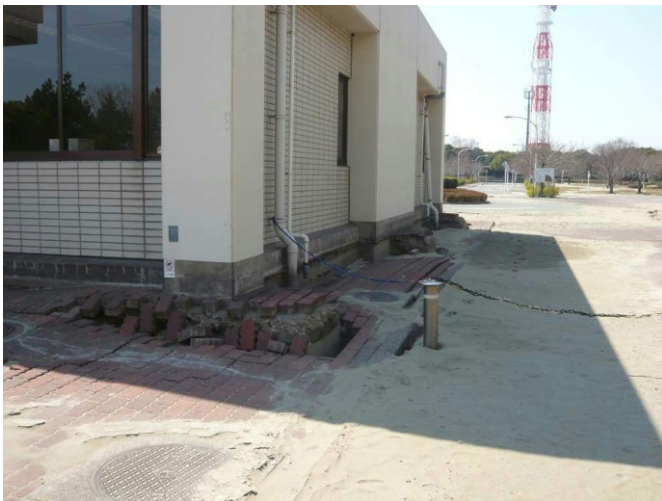
(b) Punching settlement along the periphery of the office building in the Traffic Park - a view to the south

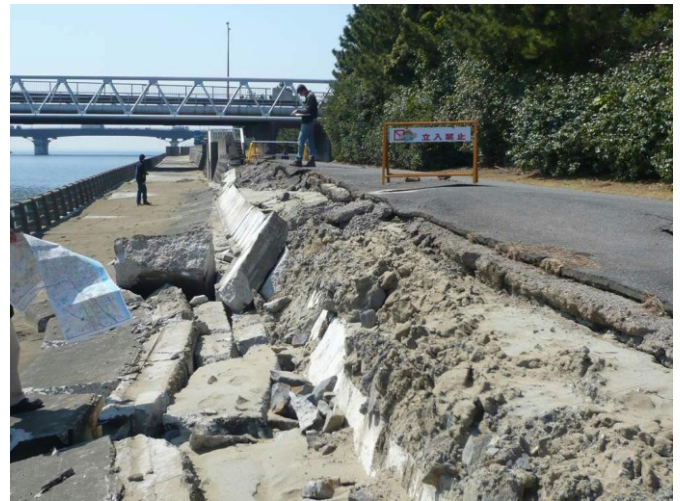
(b) Collapse of the wall north of the Hanami River – a view from the east to the sea

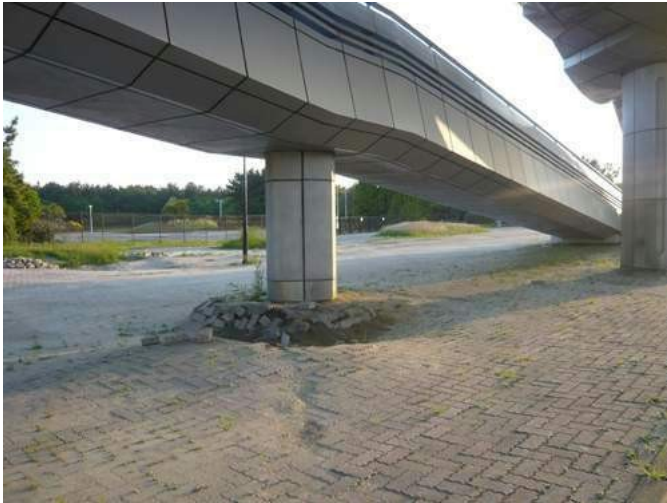
Figure 34 Annular sag in the liquefied ground surrounding the column for the cross-road walkway bridge
